The BOUSSOLE project technical reports; report #7-21, issue 1.

BOUSSOLE buoy deployment & maintenance log.

June 7, 2016 - June 1, 2017

BOUSSOLE project

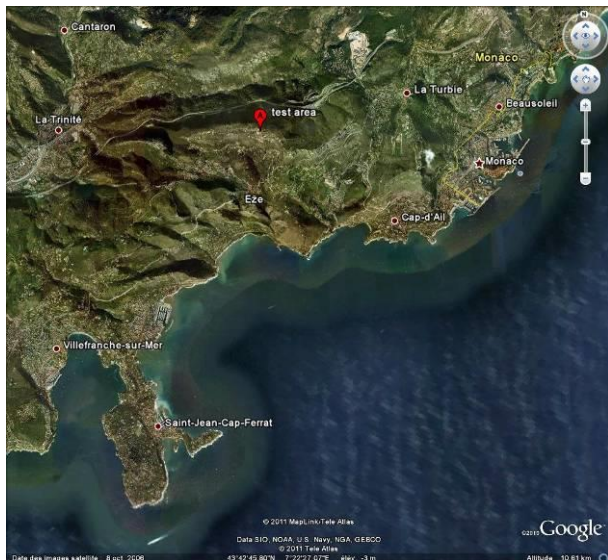
On February 3th 2013 a field campaign to test the buoy radiometers relative performances was organized at the Fort de la Revere. The fort is located at north of the Eze village at about 700m on the sea level (see images below), and near the fort there's a plane field free of obstacles that could cause shadow or glint above radiometers.

Data were acquired for about 8 hours.

Sky conditions were good. The choice to compare single data by using the TIMETAG variable recorded in data files was maintained.

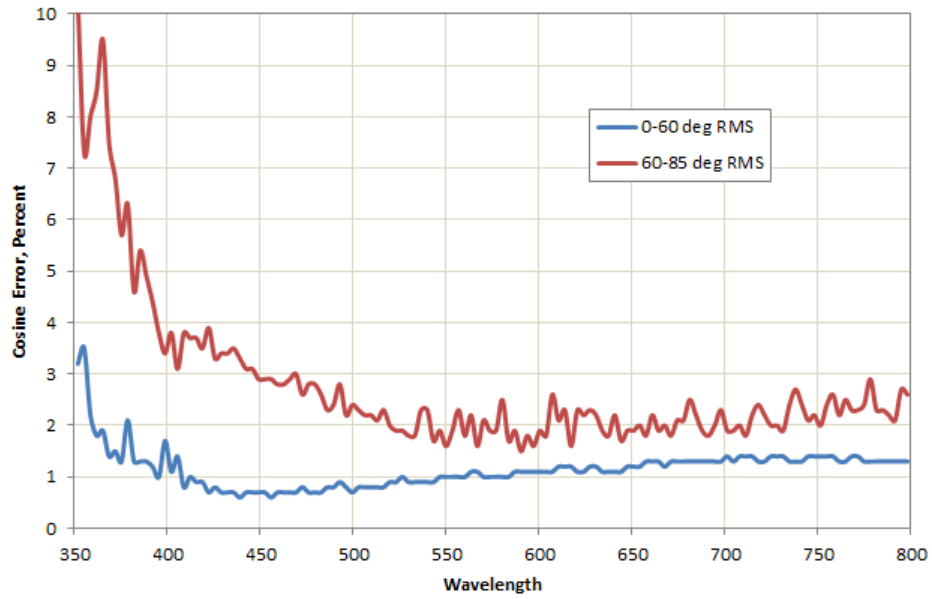
Scan 741, HOCR, HSE, sn 327

The increased error at the short wavelengths is primarily a result of noise due to low lamp UV output.

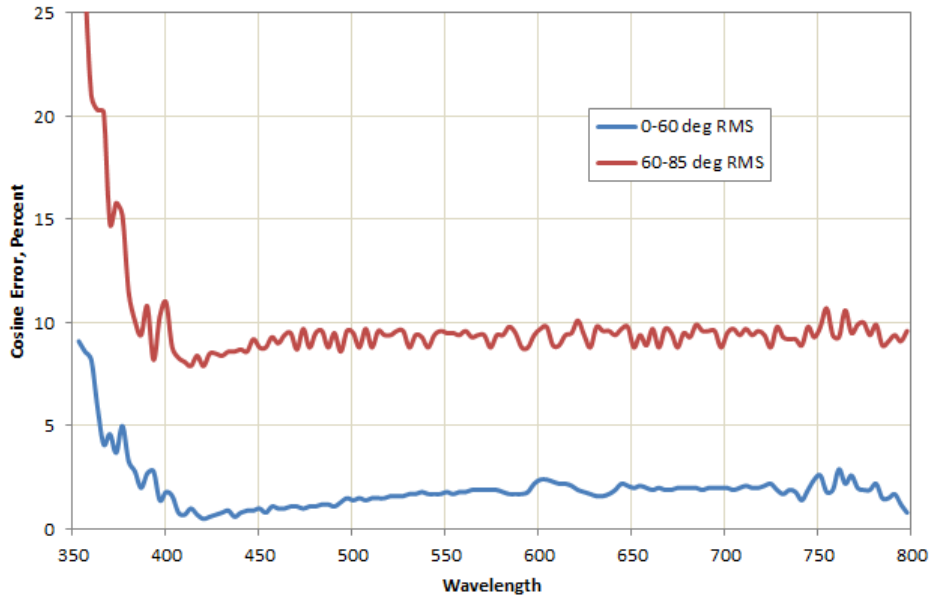
Scan 742, HOCR, HPE, sn 421

The increased error at the short wavelengths is primarily a result of noise due to low lamp UV output.

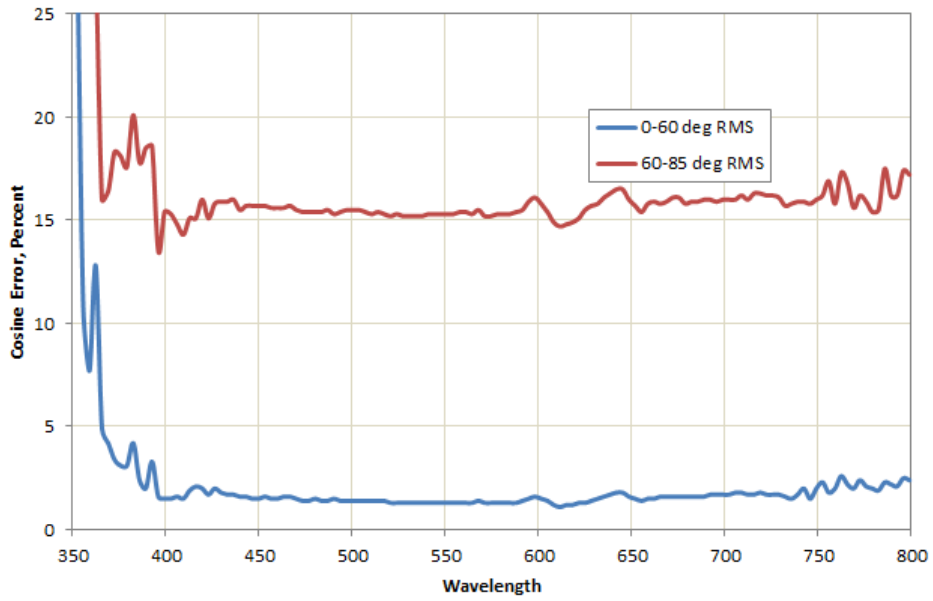
Scan 743, HOCR, HPE, sn 422

The increased error at the short wavelengths is primarily a result of noise due to low lamp UV output.

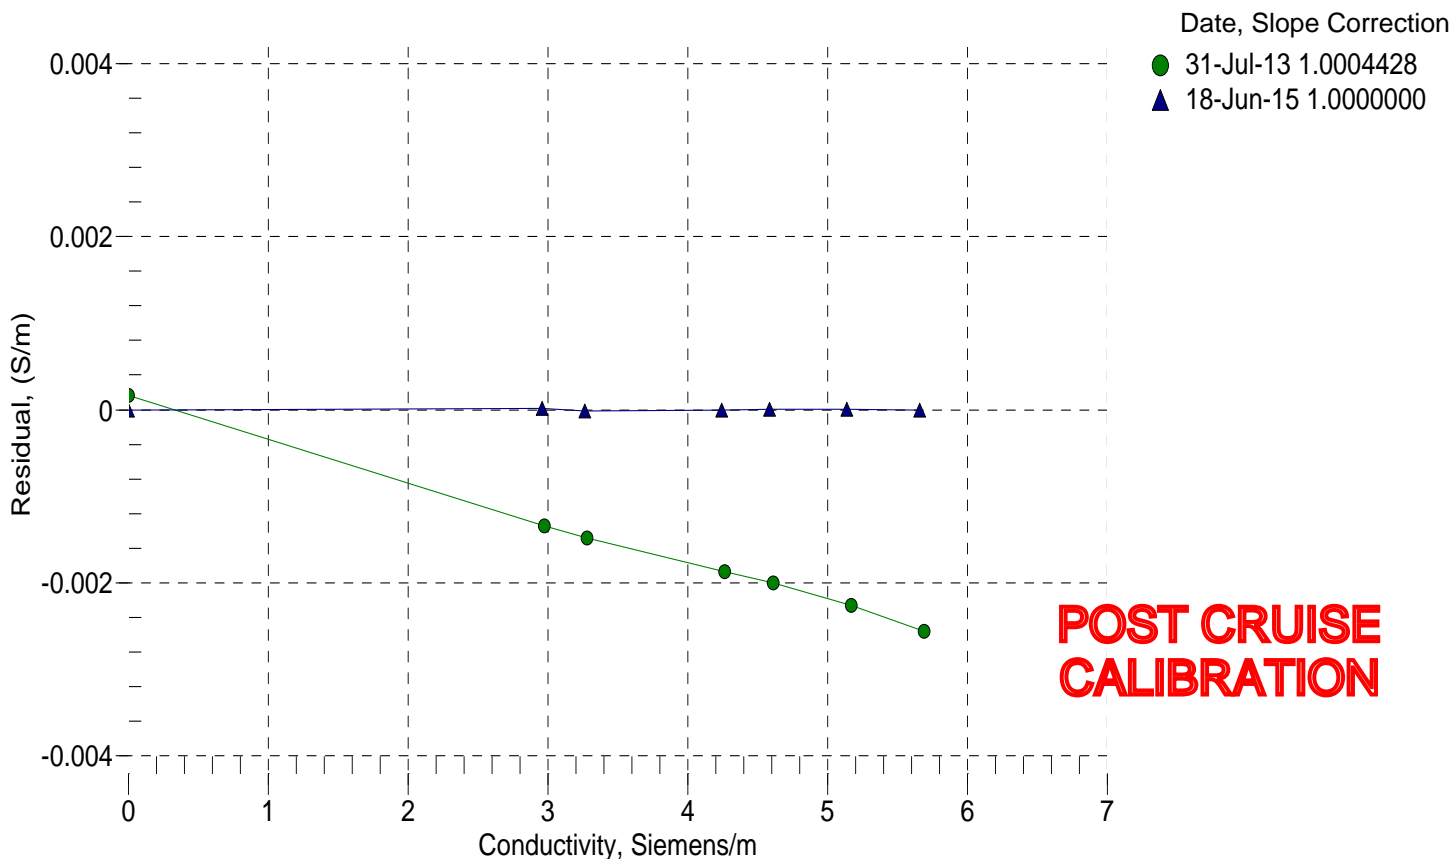
$$t = \text{temperature} [^{\circ}\text{C}]; p = \text{pressure} [\text{decibars}]; \delta = \text{CTcor}; \epsilon = \text{CPcor};$$

$$\text{Residual} = \text{instrument conductivity} - \text{bath conductivity}$$

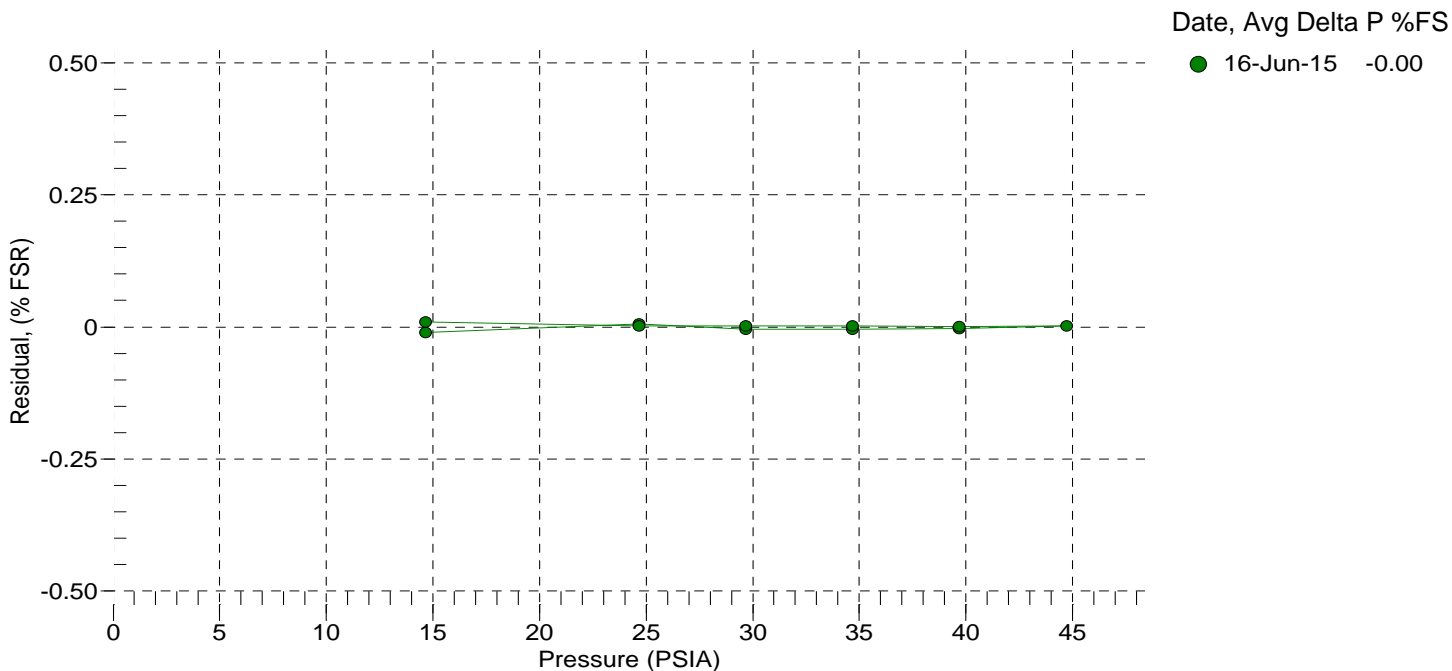
$$n = x * \text{PTCB0} / (\text{PTCB0} + \text{PTCB1} * t + \text{PTCB2} * t^2)$$

$$\text{pressure (psia)} = \text{PA0} + \text{PA1} * n + \text{PA2} * n^2$$

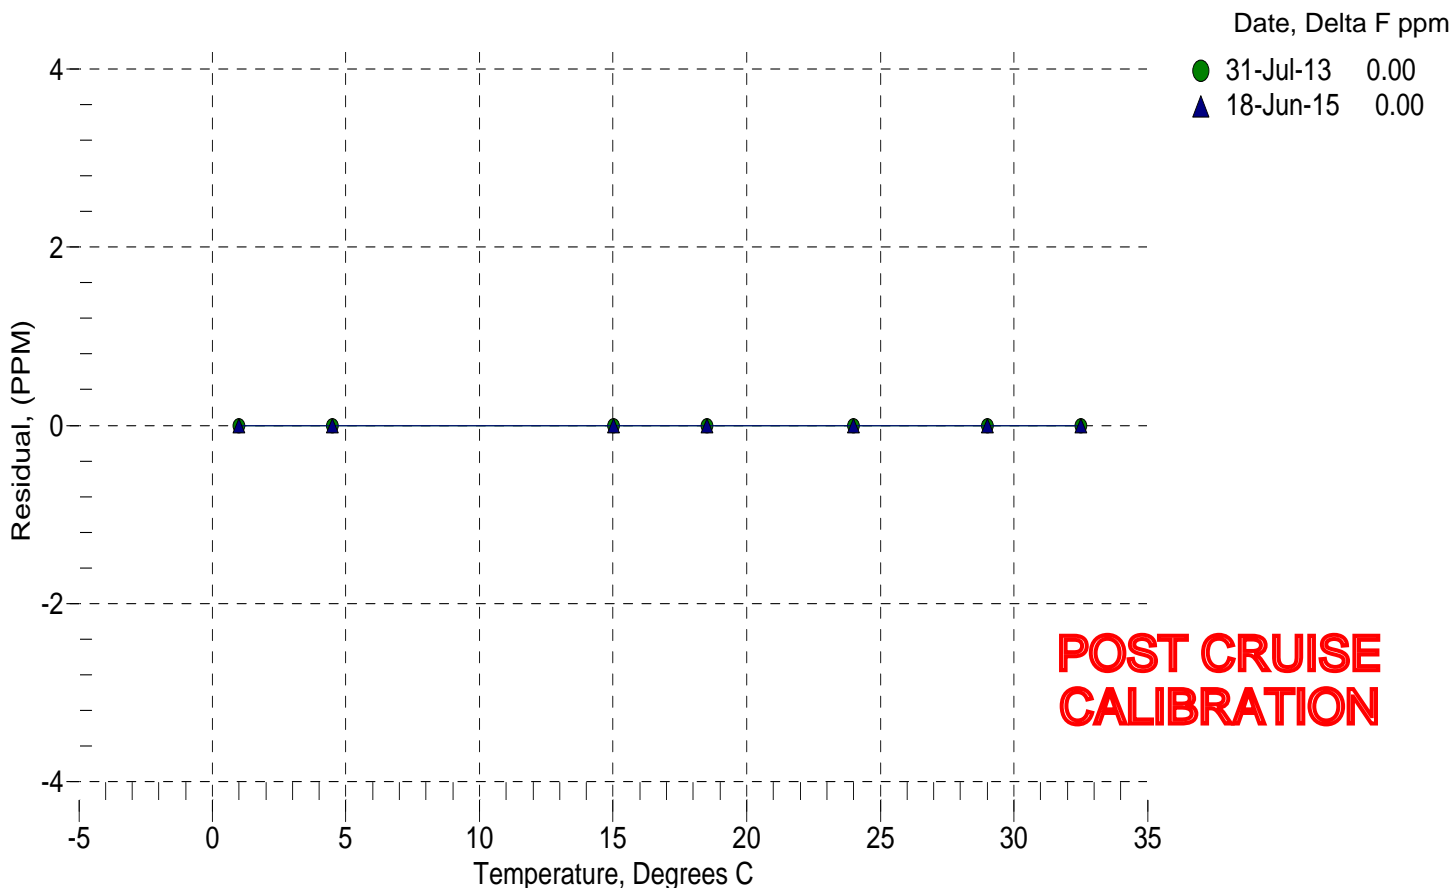
$$\text{RTC frequency} = \text{rtca0} + \text{rtca1} * t + \text{rtca2} * t^2$$

$$\text{Residual} = (\text{Computed RTC frequency} - \text{Measured RTC frequency}) * 1e6$$

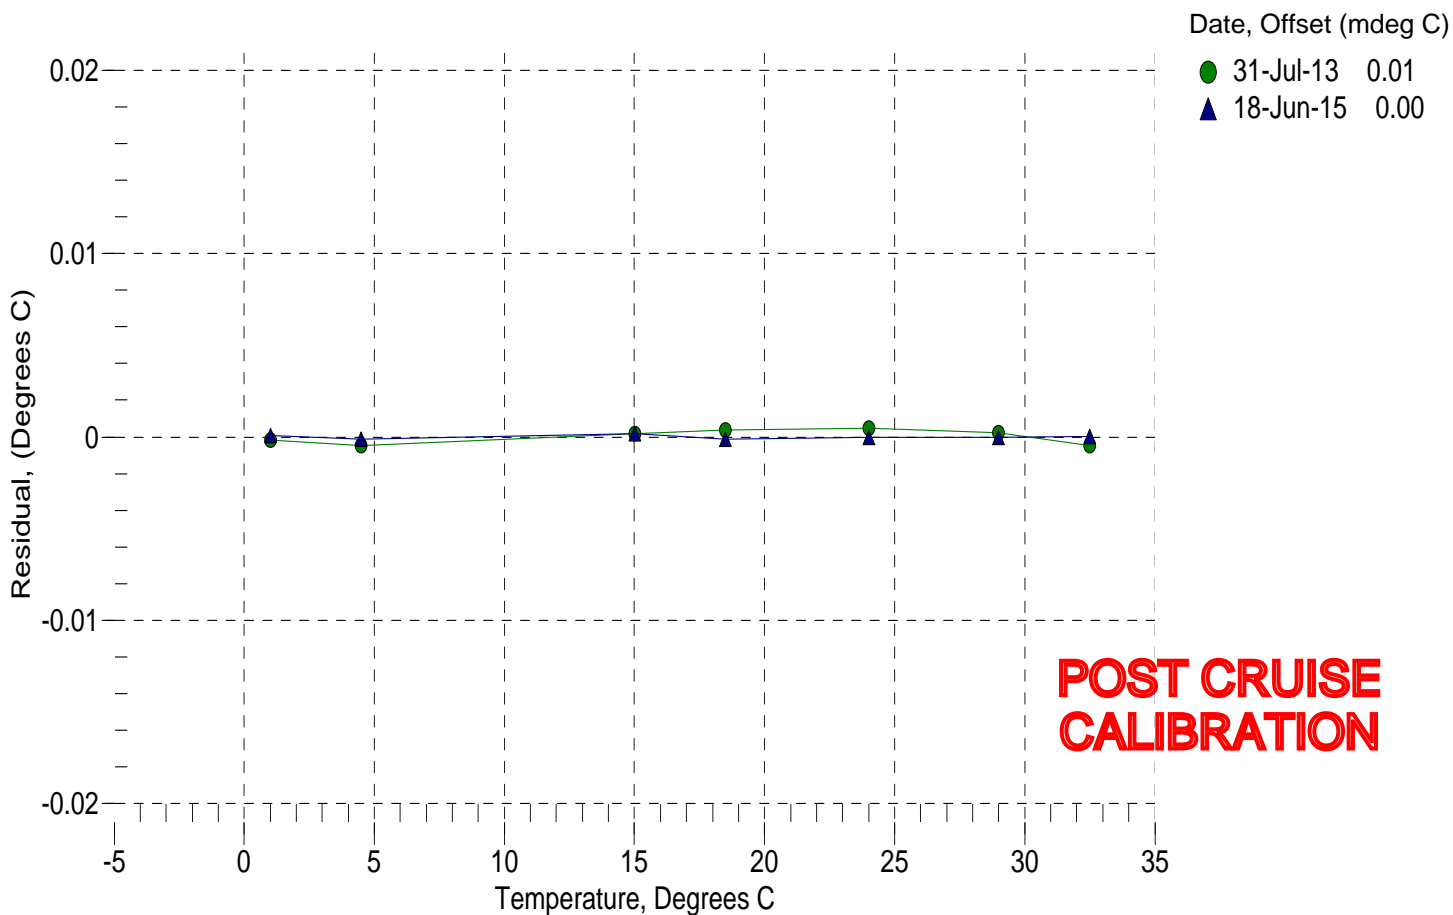
Residual = instrument temperature - bath temperature

n = instrument output

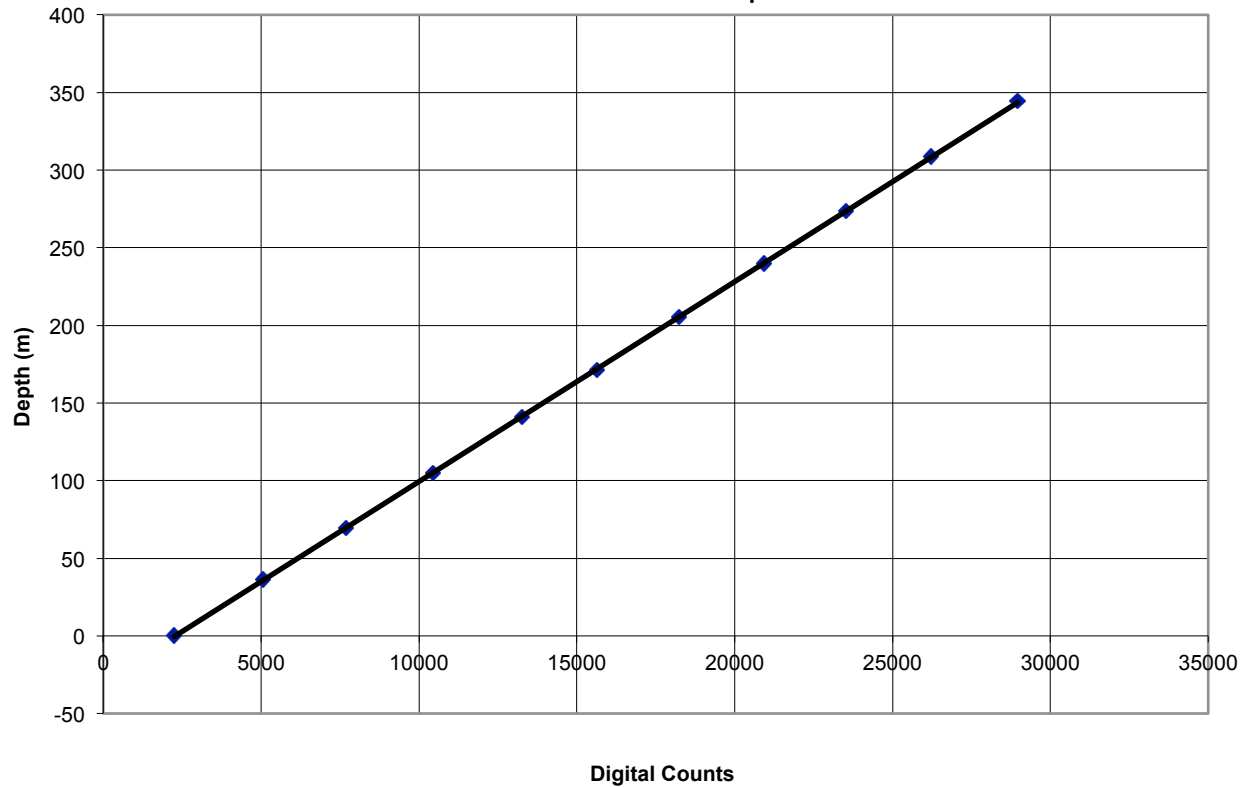
Pressure Transducer Response

$R^2 = 1.000$
