Full rotation of the BOUSSOLE buoy and mooring

August 26-29, 2016

V. VELLUCCI

BOUSSOLE Project

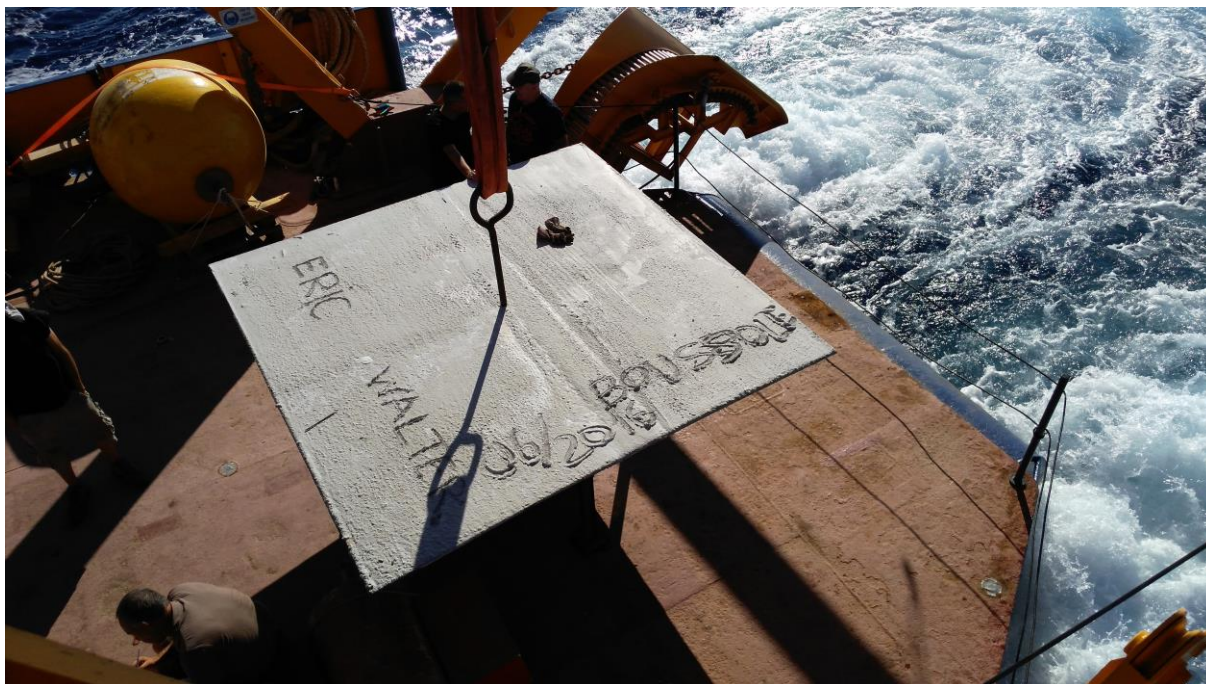
Picture of the dead weight on the deck of the “Castor 02” vessel, ready to be deployed at BOUSSOLE.

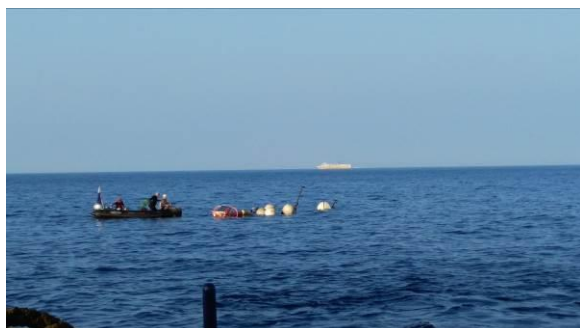
Pic. 3

- 07.30 The zodiac is deployed and divers go on the buoy to switch off the Junction Box and dismantling the buoy mast.
- 08.10 The buoy mast is dismantled and floating at surface (**Pic. 3**).

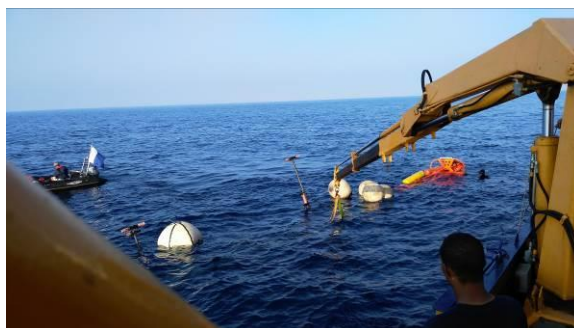
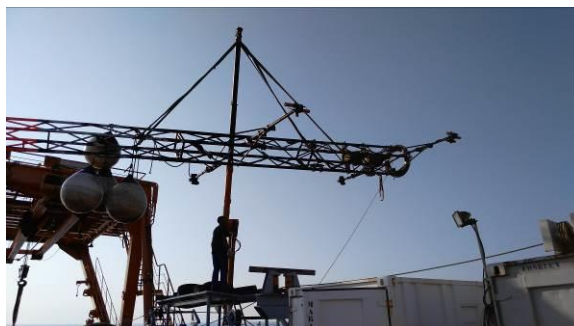
- 08.30 The buoy mast is trailed close to the Castor and lifted with the crane (**Pic. 4-6**).
- 08.45 The Castor stands about 350 m away from the BOUSSOLE position. The mooring line is released at the first attempt and the lower superstructure comes up at surface (**Pic. 7**). The ascent of the acoustic releases towards the surface is monitored by interrogating them at regular intervals.

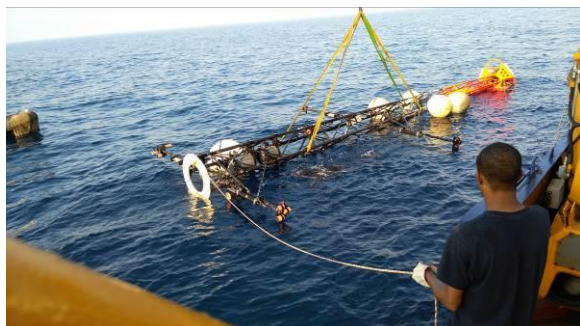
Pic. 5

When *en route* from La Seyne-sur-Mer to BOUSSOLE, plastic washers were fixed with epoxy glue (“Araldite” brand) on the buoy plate to avoid contact between stainless steel bolts and the buoy, which is made of simple steel (see **Pic. 5**).

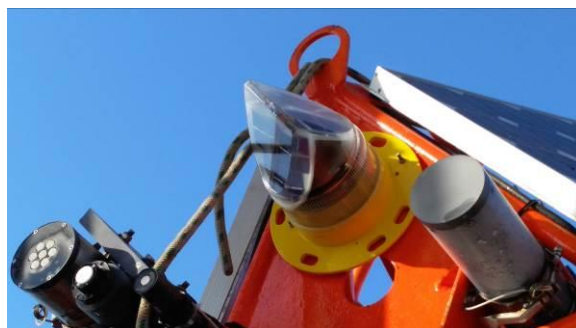
Pic. 8

- 09.00 The buoy mast is onboard and fixed on the ship deck over the zodiac platform. The headlight on the buoy mast was flood (**Pic. 8**) and the antifouling paint suffered strong degradation. A boat is rapidly approaching the lower superstructure and has to be stopped by the Castor 02 captain.

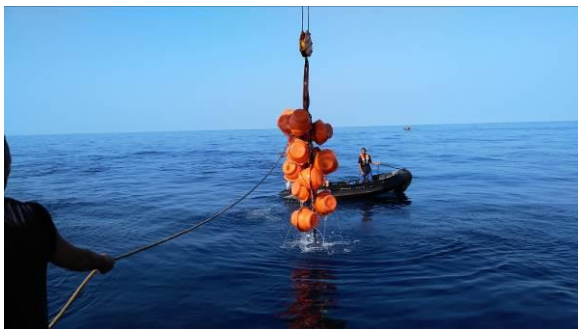
Pic. 9

- 09.15 Orange floats at surface. Preparation to recover the mooring line.
- 09.40 The zodiac reaches the mooring line and brings it close to the ship for starting its recovery (**Pic. 9**).

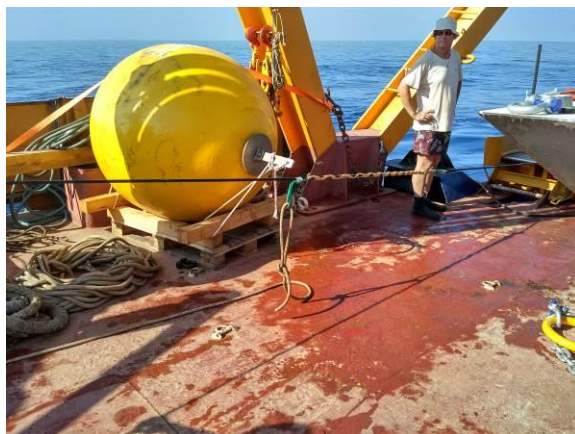
Pic. 12

- 10.40 Start of the recovery of the Kevlar cable (**Pic. 12**). The swell has increased to about 0.6 m.
- 12.00 End of the Kevlar cable recovery, the lower superstructure is partially put on board to remove the chain and the strain sensor. The general condition of the structure is good, though a lot of fouling is present on the structure itself and the first meters of the Kevlar cable. Signs of wear are present at one of the interfaces between the structure and the strain sensor. The ARGOS emergency beacon is dismantled too.

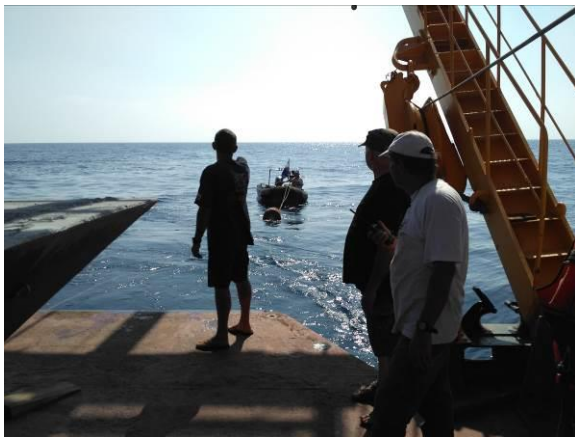
Pic. 20

- 15.30 Data download from the 2 pCO₂ sensors and CTD at 3 m.
- 15.45 The small (100 kg) float with the 70 m textile rope is deployed (**Pic. 20**). The zodiac is at sea and keeps the line away from the ship.

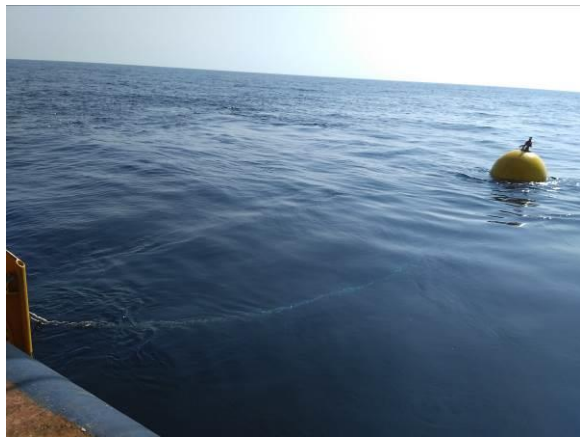
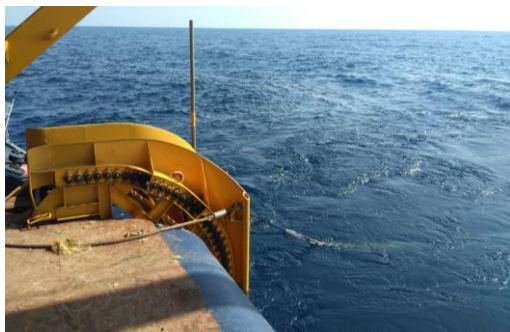
- 15.55 The big (630 kg) float is deployed with the 20 m chain (**Pic. 21**), soon after the Kevlar cable deployment starts (**Pic. 22**).
- 16.30 The emergency ARGOS beacon with new batteries is mounted onto the new lower superstructure along with the pCO₂ and O₂ sensors.

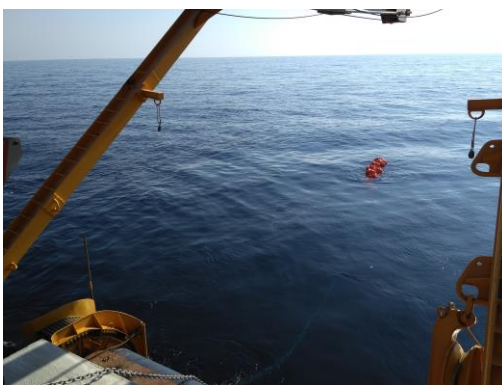
Pic. 24

- 17.05 The Kevlar cable is completely unwind, its lower termination is fixed to the chain. The 10 T dead weight is secured with the 25 T winch.
- 17.07 The orange floatation sphere and acoustic releases are deployed (**Pic. 24**).

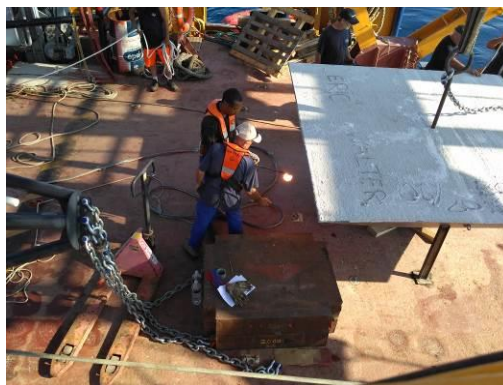
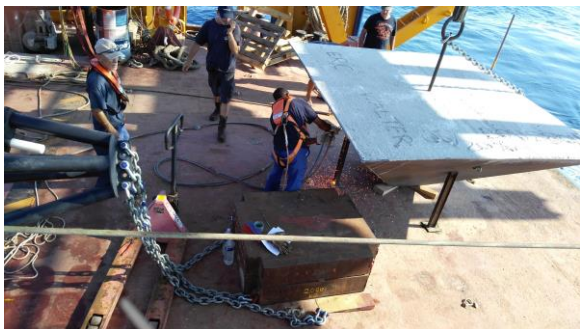
- 17.10 The 4 support feet are cut off the ship deck (**Pic. 25-26**) the ship heads to the deployment point.
- 17.16 The sling is cut and the dead weight dives.

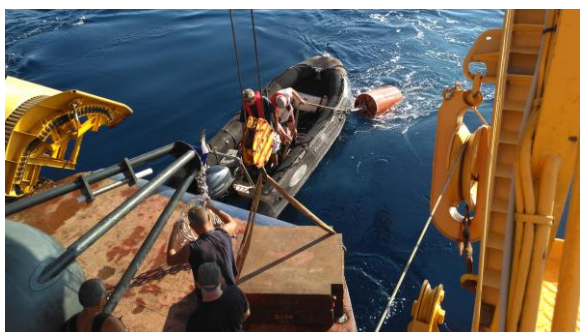
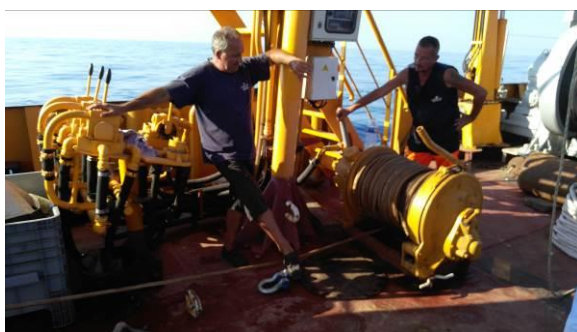
- 17.50 The 100 kg float is recovered on board and the line is kept with the port winch through the 70 m textile rope (**Pic. 28-29**). The rope tension is progressively increased to 2.7 T. This is verified through the tension display. During this operation, the ship should be as close as possible to the exact vertical of the mooring point where the dead weight ended up sinking.

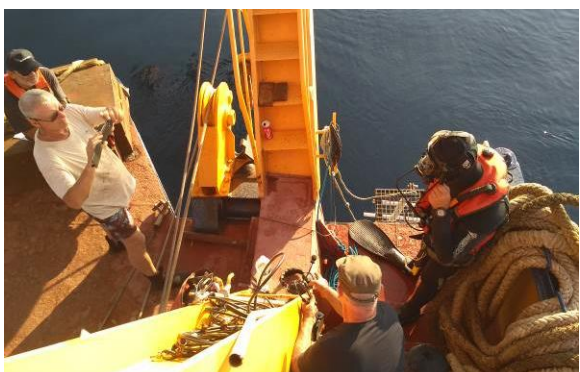
- 18.35 Tension on the rope is stabilized Divers prepare to go at sea (**Pic. 30**).
- 18.55 The 630 kg float is at surface and loaded onto the ship (**Pic. 31**). Divers on board.

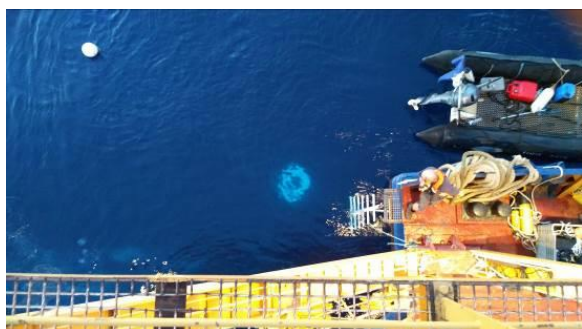
Pic. 37

- 20.20 Divers install a small white float to easily locate the mooring position (**Pic. 37**) and dismount 9 m of exceeding chain
- 20.35 Divers on board, operations on standby. The new mooring position is 43°22.0540 N 7°54.1150 E. The distance from the dead weight release point is only 27 m. The upper part of the lower superstructure is at 8.20 m, it will have to be lowered the day after.

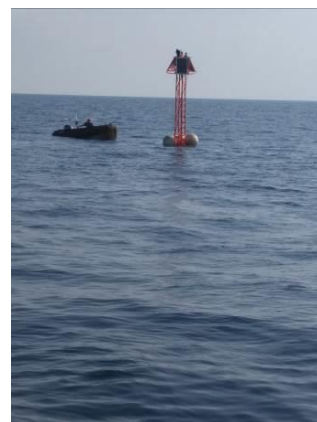
Pic. 41

- 10.45 The mast mounting is complete (**Pic. 41**).
- 11.15 VV goes on the buoy. The battery and the Junction box are switched on. An AK attempt of connection with the buoy failed. However at 11.30 the buoy Ethernet connection was open and the sound of shutter of the hyperspectral reference confirmed the buoy functioning.
